**ASBESTOS & LEAD-BASED PAINT SURVEY**

**FIRE ALARM BUILDING  
333 PRESTON AVENUE  
HOUSTON, HARRIS COUNTY, TEXAS**

**SEPTEMBER 29, 2005**

**Re: Asbestos and Lead-Based Paint Survey  
Fire Alarm Building  
333 Preston, Houston, Texas  
ECS Project Number: 50825130  
City of Houston Contact Number: 53564**

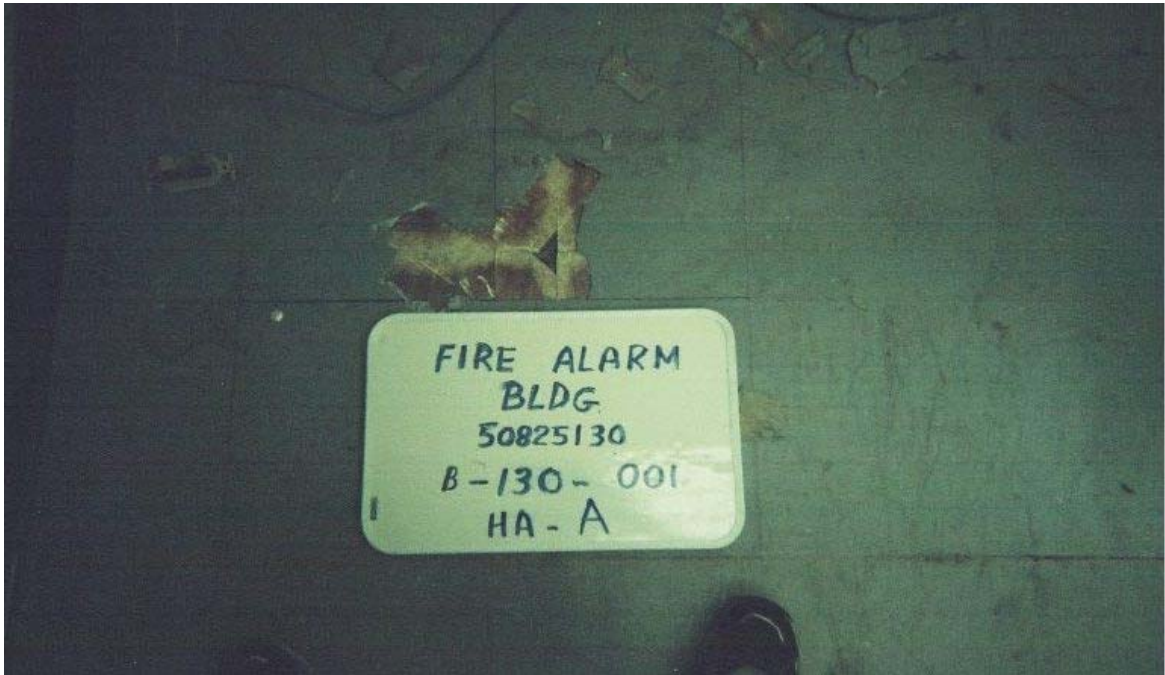
- **12” Vinyl Floor Tile:** Approximately six hundred seventy two (672) square feet gray black vinyl floor tile over white floor tile with black mastic were located in rooms 101, 102 and 103 within the facility that appeared to be in good condition at the time of our site visit. Asbestos present, no action necessary unless renovation, remodeling or demolition is planned (City of Houston Category C-3).
- **12” Square Vinyl Floor Tile:** Approximately one thousand six hundred (1,600) square feet of 12” square white vinyl floor tile over black mastic material was located on the first floor throughout building that appeared to be in good condition at the time of our site visit. Asbestos present, no action necessary unless renovation, remodeling or demolition is planned (City of Houston Category C-3).

Photo No. 1: B-130-001 ACM 12x12 Gray / off white / black floor tile with mastic

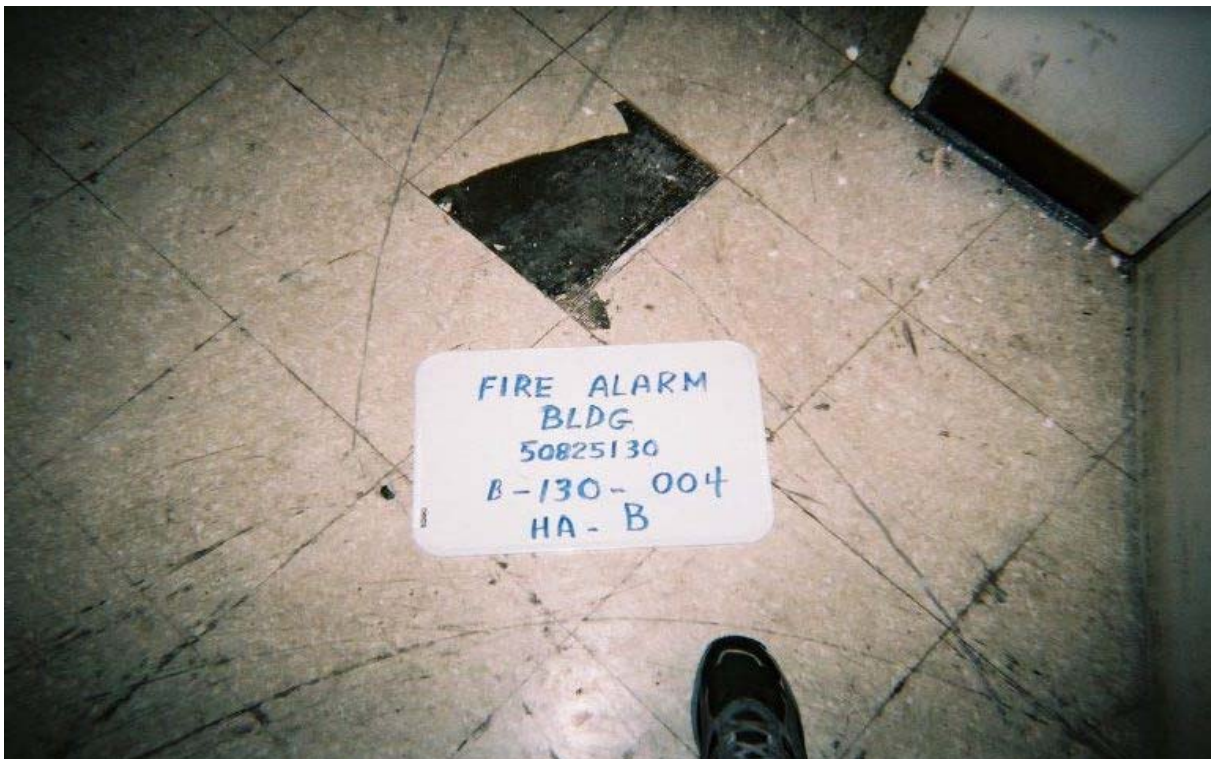
- **12" Square Vinyl Floor Tile: Approximately one thousand six hundred (1,600) square feet of 12" square white vinyl floor tile over black mastic material was located on the first floor throughout building that appeared to be in good condition at the time of our site visit.**

Photo No. 2: B-130-004 ACM 12x12 White / black floor tile with mastic

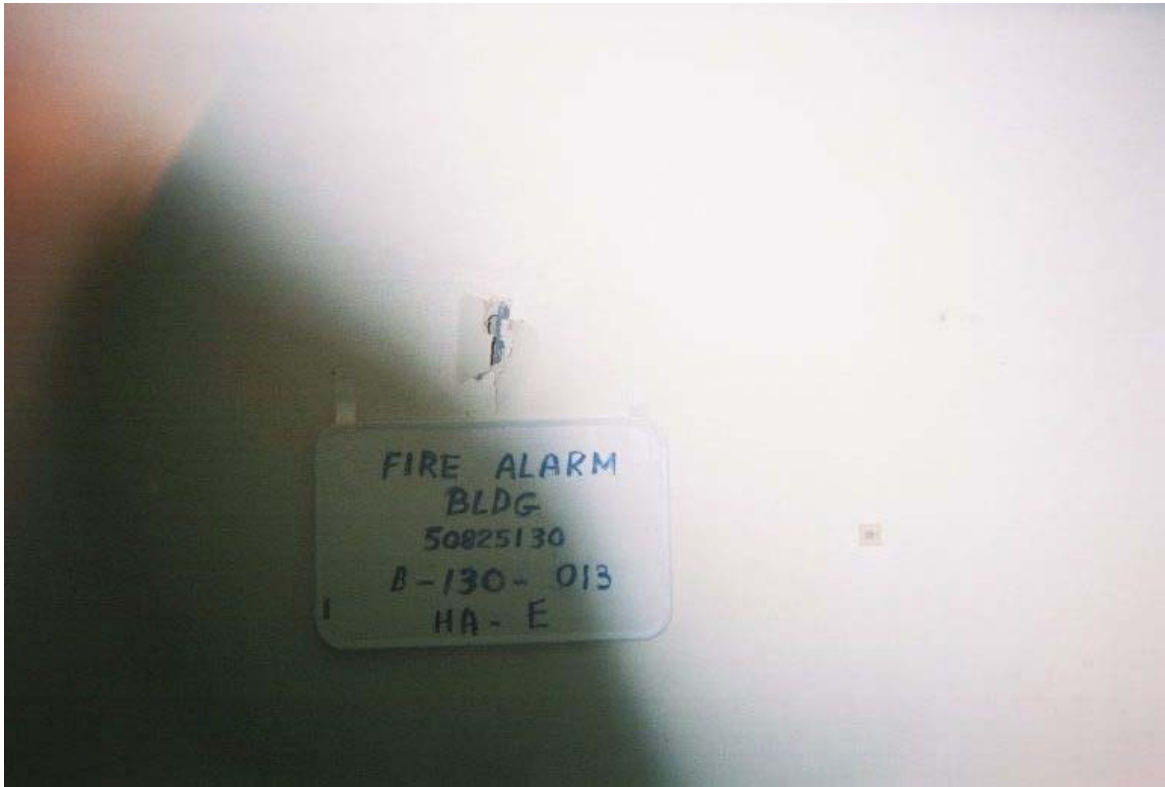
- **Sheetrock, Joint Compound, and Texture Walls and Ceilings: Approximately three thousand five hundred fifty (3,550) square feet were located on the north half of the first floor that appeared to be in good condition at the time of our visit. Asbestos present, no action necessary unless renovation, remodeling or demolition is planned (City of Houston Category C-3).**

Photo No. 3: B-130-013 ACM Sheet rock / Joint compound / texture, white

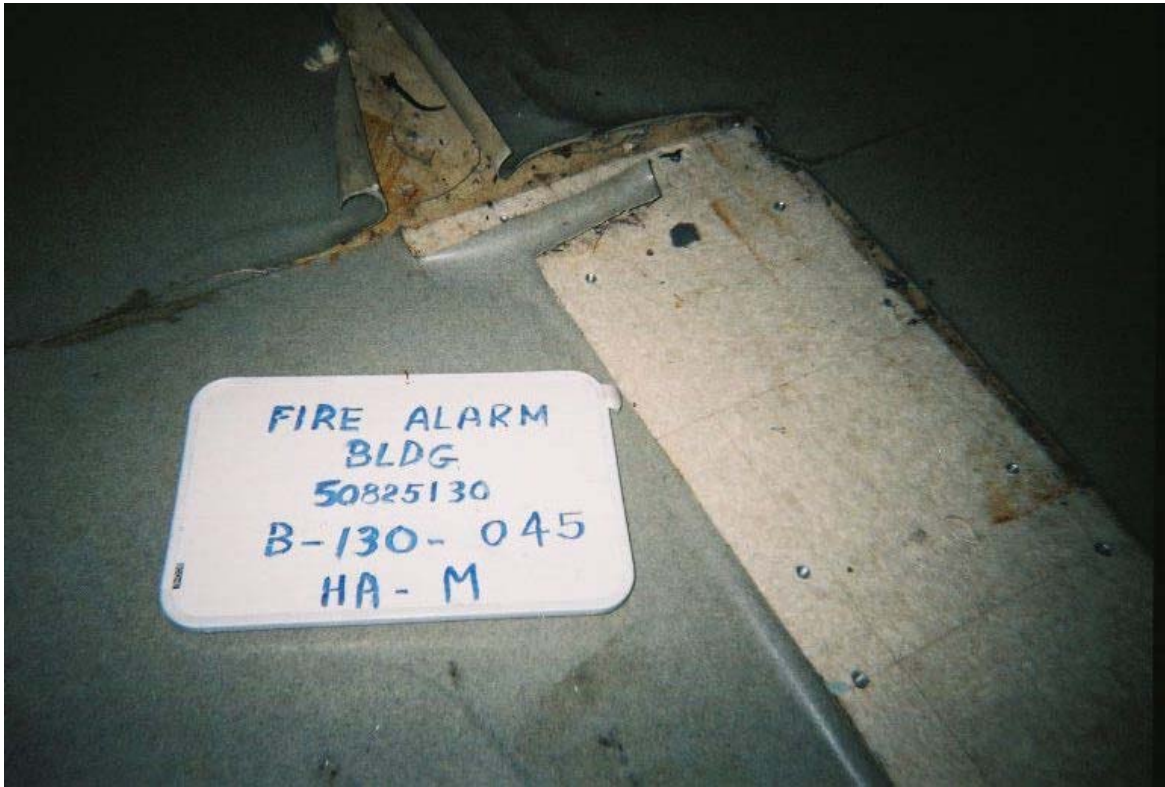
- **Gray/White/Black Roll Flooring: Approximately five hundred (500) square feet were located over white 12" x 12" floor tile and black mastic in the Radio Room on the second floor that appeared to be in good condition at the time of our visit.**

Photo No. 5: B-130-045 ACM Roll flooring / Gray / White / Black

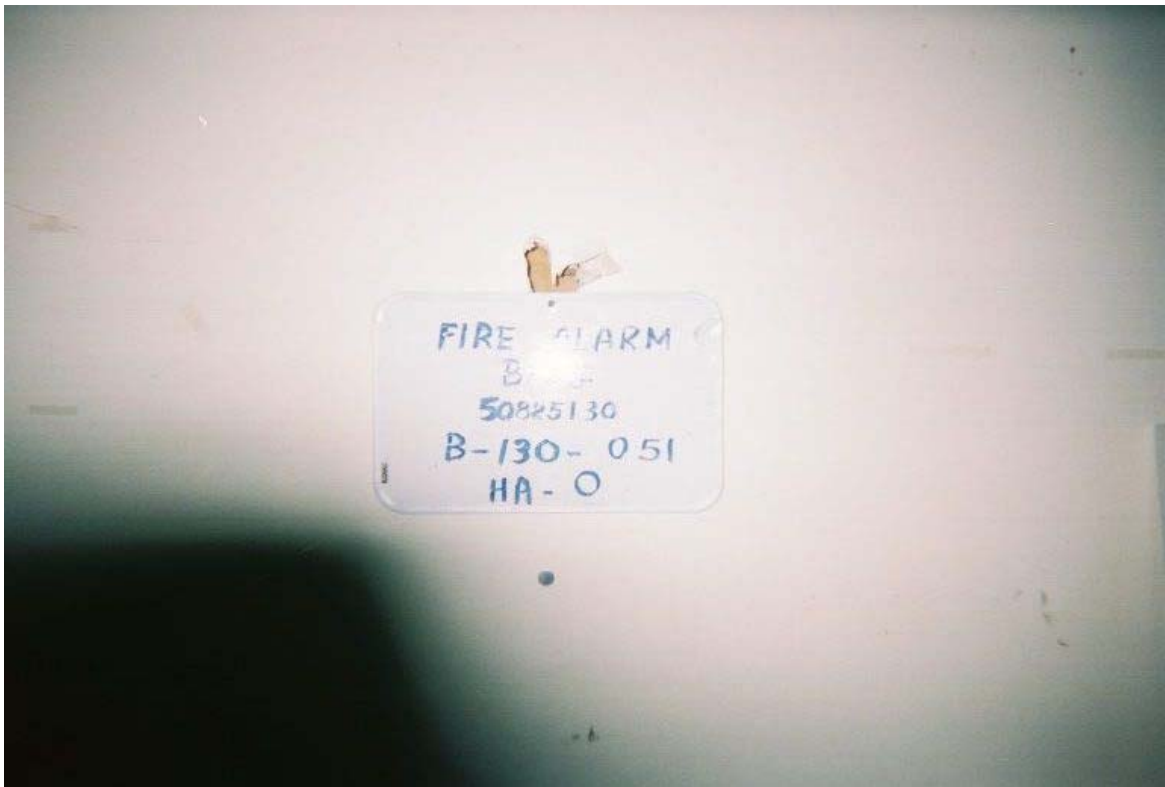
- **Off White Sheetrock and Joint Compound Walls:** Approximately eight thousand (8,000) square feet were located throughout the second floor except the fire alarm room that appeared to be in good condition at the time of our visit. Asbestos present, no action necessary unless renovation, remodeling or demolition is planned (City of Houston Category C-3).

Photo No. 7: B-130-051 ACM Sheet rock / Joint compound

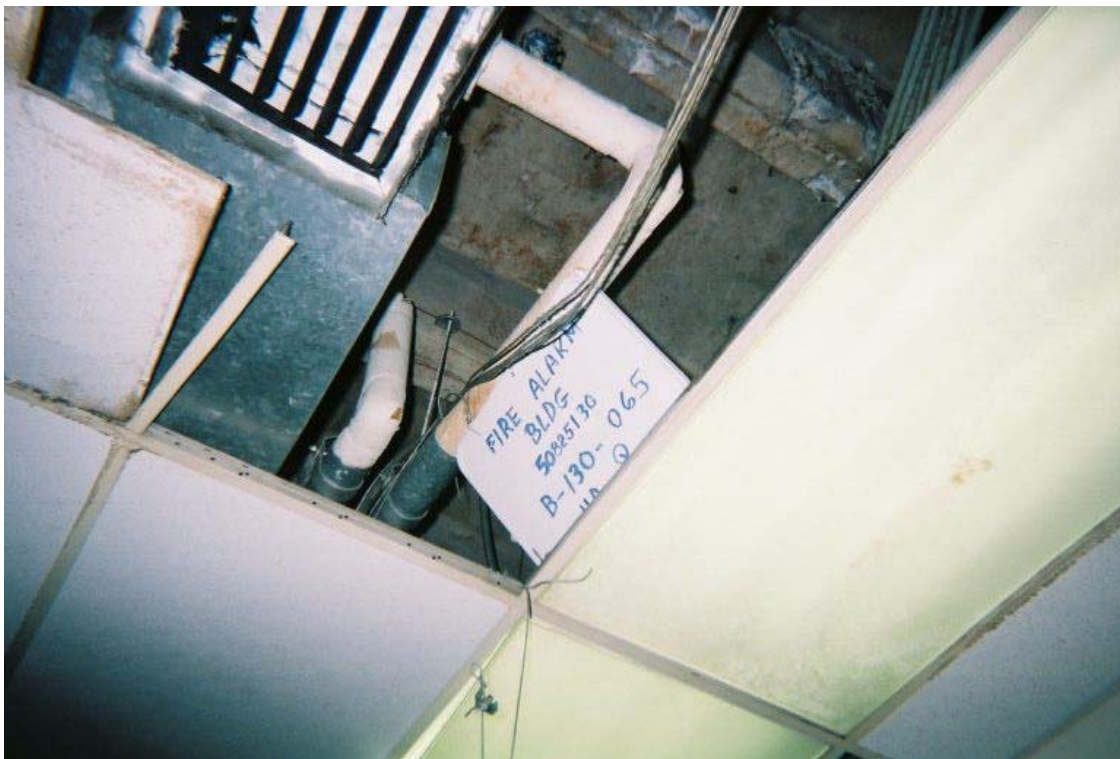
- **White TSI Elbows T's:** Approximately sixty five (65) linear feet were located above the suspended ceiling tile on the second floor that appeared to be in good condition at the time of our visit. Asbestos present, no action necessary unless renovation, remodeling or demolition is planned (City of Houston Category C-3).

Photo No. 8: B-130-065 ACM TSI white / yellow above suspended ceiling outside room 205

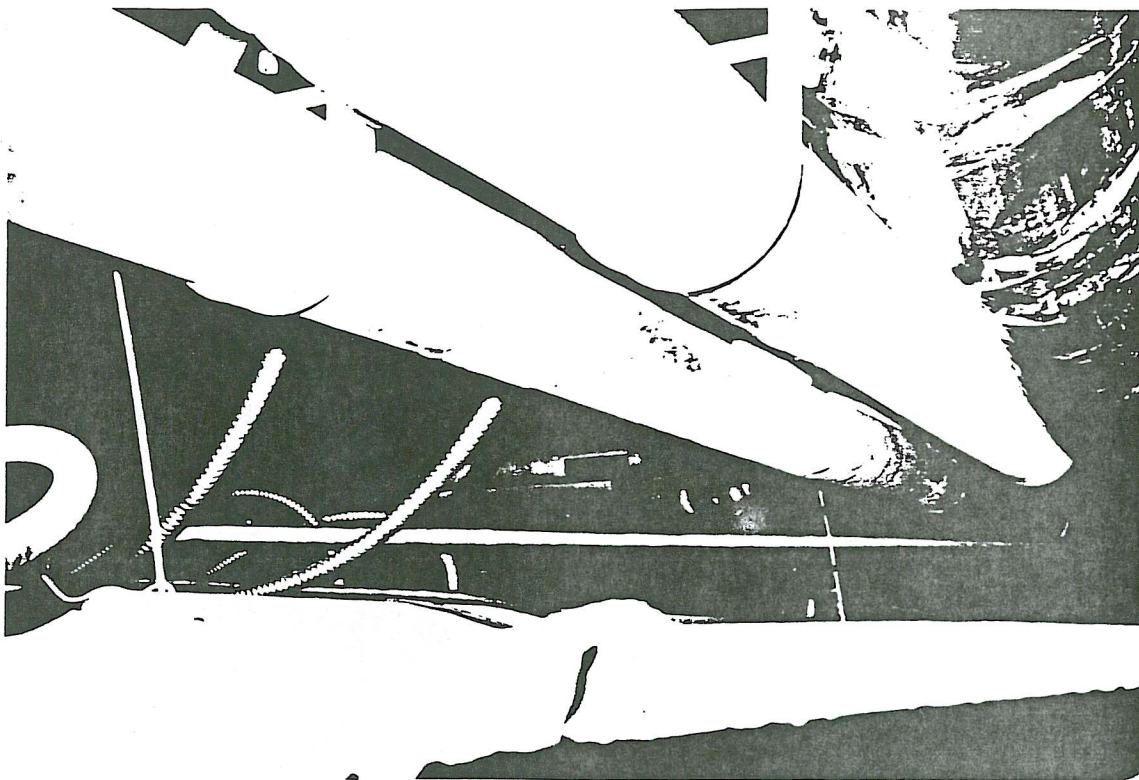
PIPING & INSULATION ABOVE  
COMPUTER ROOM #3

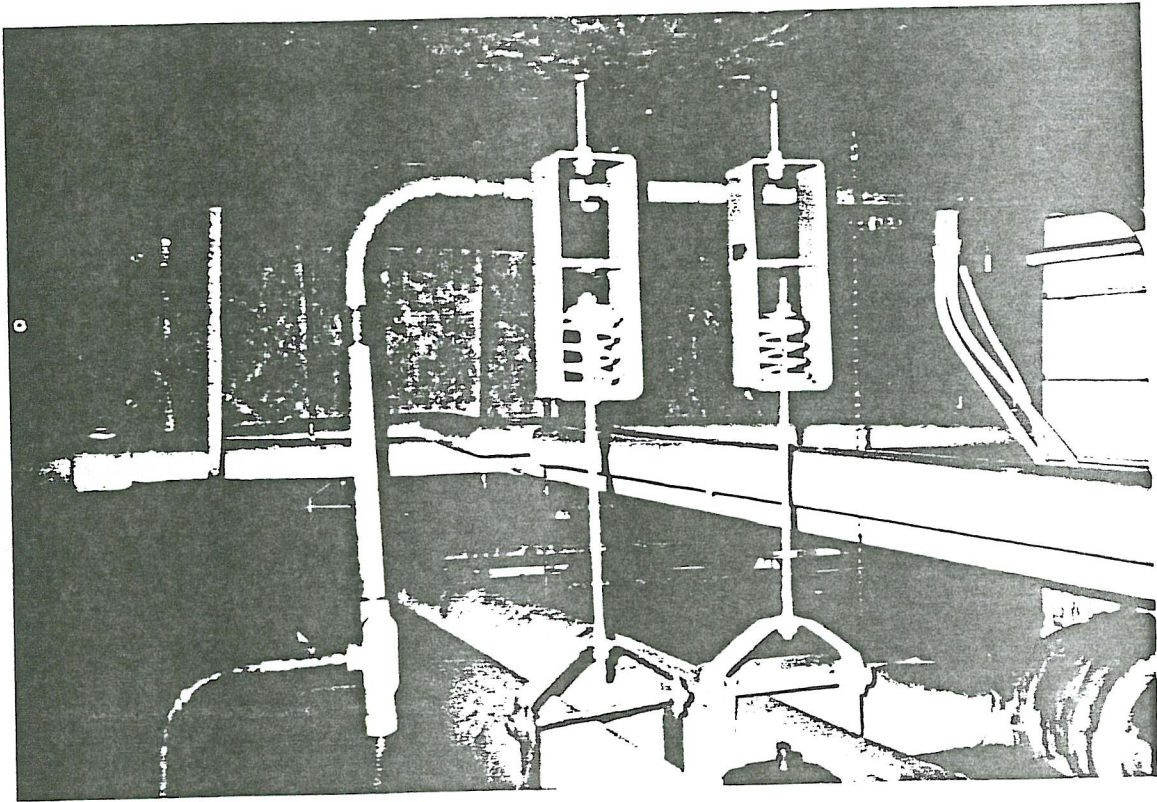
PIPE & FITTING INSULATION MECHANICAL ROOM
